BUSINESS CASE

KLM FLIGHT 4805

The burden of speaking up

KLM flight 4805: in a hurry

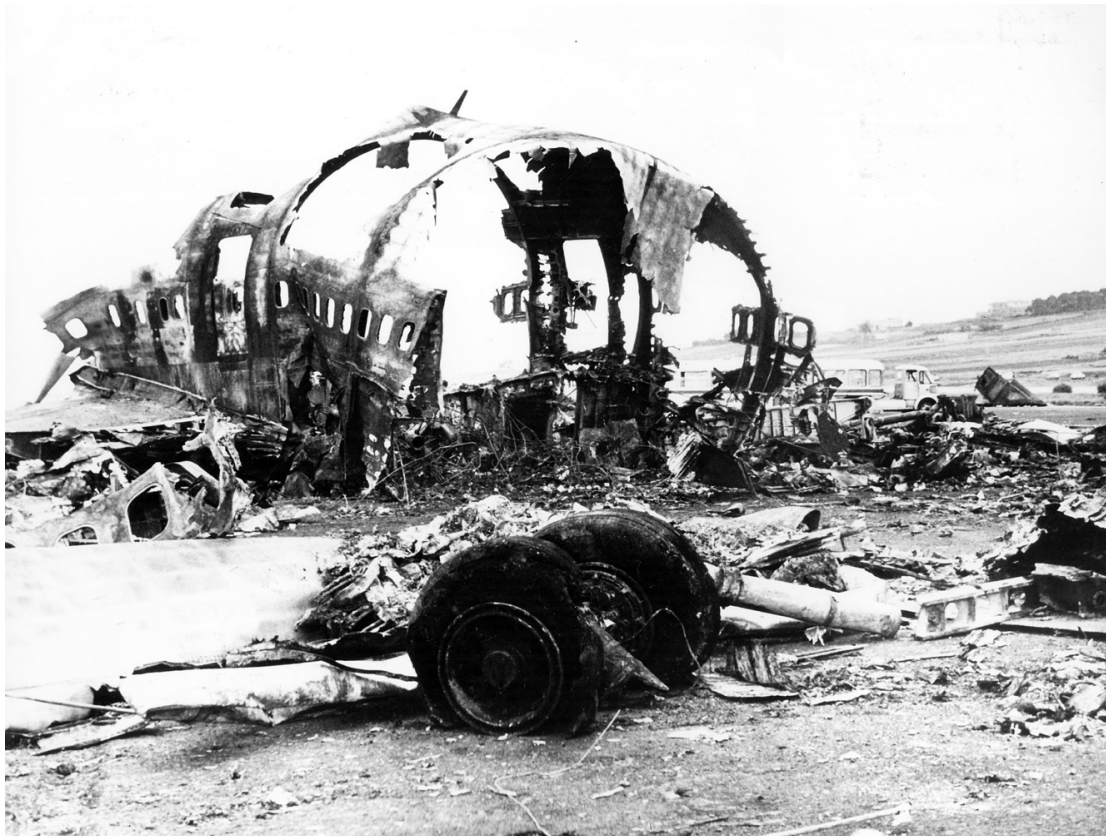
to lift off the ground before reaching the Pan Am flight, but it was too little, too late. Part of its landing gear caught the rear of the Pan Am cabin, while the engine on the far right ripped off the roof of the Pan Am cockpit. The KLM plane flew for about another 500 feet before crashing into the runway and bursting into flames. All 234 passengers and 14 crew members were killed instantly. The Pan Am plane was also in flames – 317 passengers and nine crew members died. Only 63 Pan Am passengers in the front section of the plane and seven crew members survived the disaster.⁵⁹

Figure 1.13 **Wreckage of the KLM 747**
