BUSINESS CASE

KLM FLIGHT 4805

The burden of speaking up

KLM flight 4805: in a hurry

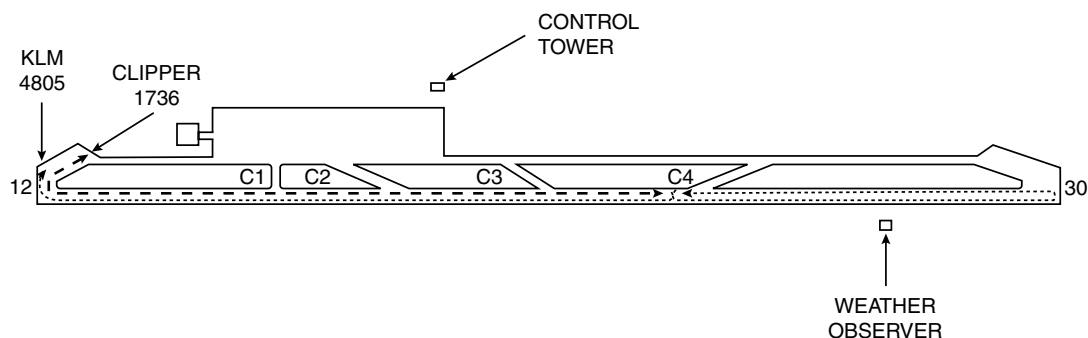
Figure 1.12 Los Rodeos Airport and runway 12/30

At 5:56 p.m., KLM flight 4805 in Los Rodeos was cleared to taxi (Figure 1.12). As large sections of the taxiways were still blocked by parked planes, KLM 4805 was told to taxi over runway 30 to reach its position on the other side of the airfield. Shortly after, Pan Am 1736 was also cleared to taxi via the same runway, following the KLM flight. With the fog now much thicker, the Pan Am crew soon lost sight of the KLM plane in front.

Both planes were supposed to leave the runway via the third taxiway (C3) and follow the usual taxiway, B, to their position on runway 30. However, both the KLM and Pan Am crews had difficulty finding C3. Bear in mind that the pilots in a Boeing 747 are nearly 28 feet above the ground. At a small airport with limited signage, and in thick fog, it is hardly surprising that the crews found it hard to spot the taxiway.

At 6:03 p.m., KLM 4805 was standing ready on runway 30. Meanwhile, the Pan Am flight was still creeping through the thick fog. Unlike the KLM flight, the Pan Am crew had managed to spot taxiway C3. However, due to the narrow curve radius, it was almost impossible to make the turn with a Boeing 747. The crew decided to taxi forward to C4, where the curve radius was more suitable for such a big aircraft.
